# Manhole Inspection Summary

Manhole # S15Y\_\_003MH

Insp Date: **6/25/08 9:38 AM**

**Location** Address: **2720 georgetown rd**

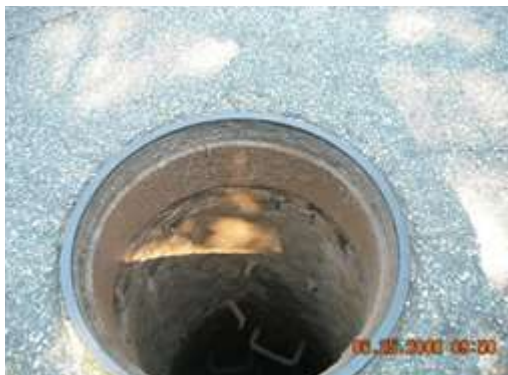
Misc

Subject To Ponding: **Sheeting**

inflow evidence from sheeting

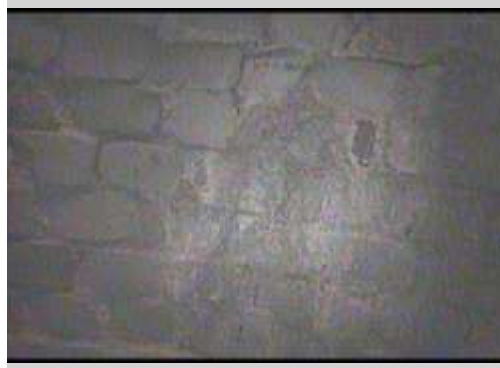
Defect 6

Infiltration: ☐ None ☐ Joint ☐ Cracks ☐ Mortar ☐ Roots ☒ **Wall**

infiltration @ barrel wall

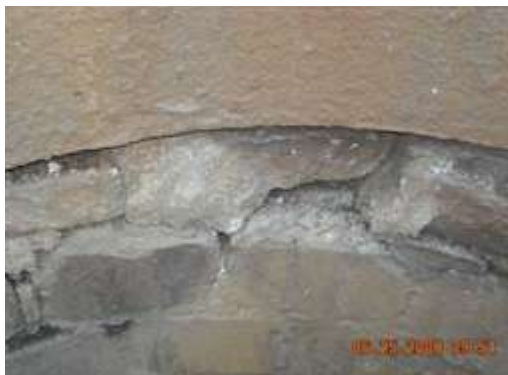
Defect 5

Condition: ☐ Sound ☒ **Cracked** ☐ Root Intrusion ☐ Loose Brick ☐ Deteriorated

cracked chimney brick

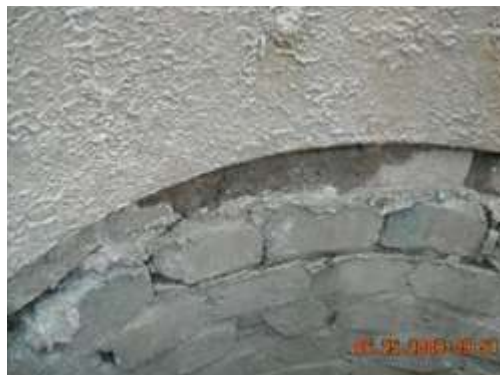
Defect 4

Infiltration: ☐ None ☒ **Joint** ☐ Cracks ☐ Mortar ☐ Roots ☐ Wall

infiltration @ chimney/frame joint

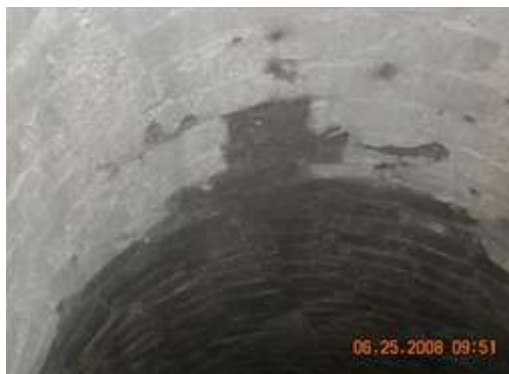
Defect 3

Infiltration: ☐ None ☐ Joint ☐ Cracks ☐ Mortar ☐ Roots ☒ **Wall**

infiltration @ corbel wall

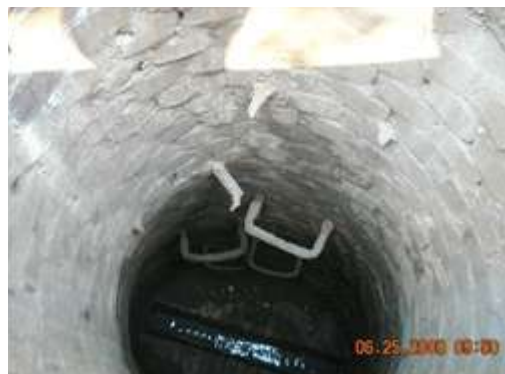
Defect 1

**Steps** Count: **4** Missing: **2** ☒ **Corroded**

corroded & missing steps

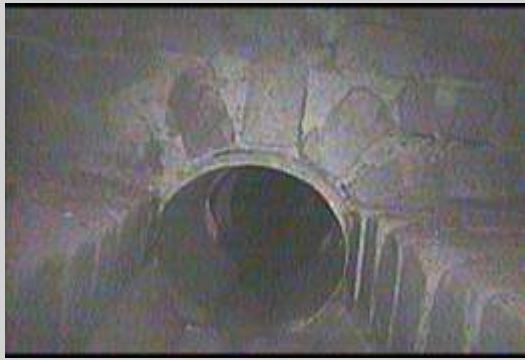
12 O'Clock Outflow

Pipe Height: **8.4** (in.) Rod and Bar (Angled)  
Pipe Material: **Clay** ☐ Pipe Lined  
Invert Depth: **10.95** (ft.) Flow Characteristics: **Slow**  
Deposits: ☒ None ☐ Mud ☐ Sludge ☐ Debris ☐ Grease  
Silt Depth: **0** (in.) Deposits Extent:  
Infiltration: **None** Pipe Seal Cond: **Sound**

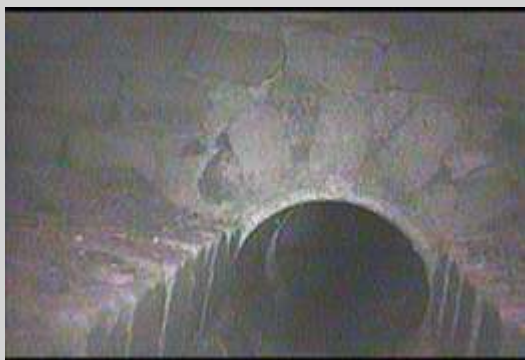
6 O'Clock Inflow

Pipe Height: **8.4** (in.) Rod and Bar (Angled)  
Pipe Material: **Clay** ☐ Pipe Lined  
Invert Depth: **10.88** (ft.) Flow Characteristics: **Slow**  
Deposits: ☒ None ☐ Mud ☐ Sludge ☐ Debris ☐ Grease  
Silt Depth: **0** (in.) Deposits Extent:  
Infiltration: **None** Pipe Seal Cond: **Sound**
